# **Flood Investigation Report**

## **St Asaph and Elwy Communities**

Storm Ciara  
9<sup>th</sup> February 2020

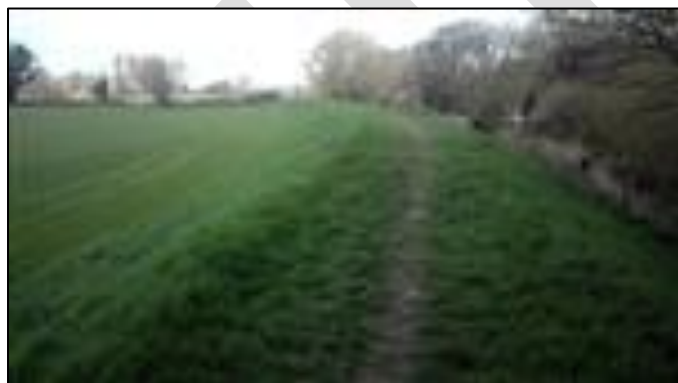
Figure 22: Elwy Fishermans Bridge Embankment (NRW, 2019)

The Elwy Fisherman's Bridge Embankment (Figure 22) was not raised during the scheme as modelling showed the crest levels were sufficient to contain the 0.5% AEP flood. At the time of the last inspection in October 2019 the embankment was in Good condition. Subsequent post-event (February 2020 & February 2021) and (May 2020) routine inspections record the embankment condition as Fair with comments "is stable and only suffered minor erosion damage".

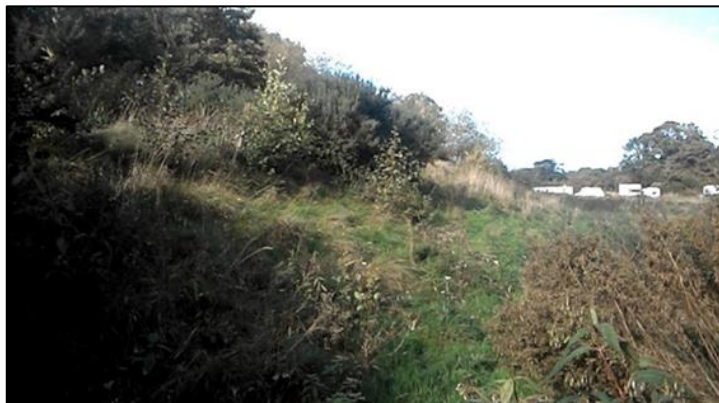
Figure 23: Elwy Mount Embankment (NRW, 2019)

The right bank embankments from high ground at Spring Gardens Caravan Park down to the fisherman's bridge were not raised during the 2018 St Asaph Scheme as they were deemed adequate to contain the design flood event. A short section of embankment just upstream and downstream of the fisherman's bridge was raised to design standard using pre-cast concrete blocks as constrictions from the highway disallowed earth embankment widening and raising.

A short section of the embankment was in Very Poor condition during the October 2019 asset inspection due to excessive vegetation growth and motorcycle damage. NRW are currently working with landowners in the area to refurbish and maintain flood risk management assets to a good condition.

**Recommendation 1.2 – NRW – Work with the landowners of Elwy Mount embankment to restore the flood risk management asset back to good condition.**

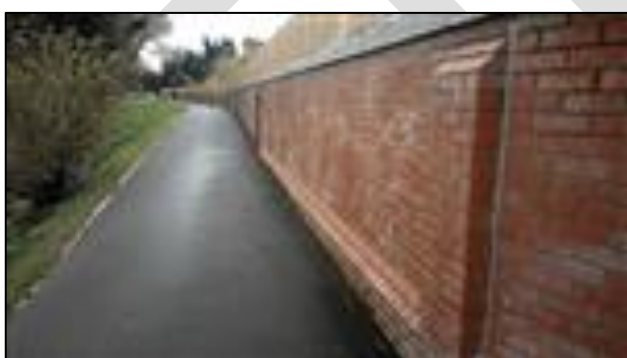
Figure 25: Roe Parc Wall (NRW, 2019)

The Roe Parc section of raised defence (Figure 25) was formally a grass covered earth embankment. In 2012 extensive overtopping was observed along this section. The 2018 scheme significantly improved the standard of protection along this section by construction of a steel sheet pile wall with brick cladding. A vertical wall was favoured to the original earth embankment due to space availability. The wall was designed to contain the 0.5% AEP event.

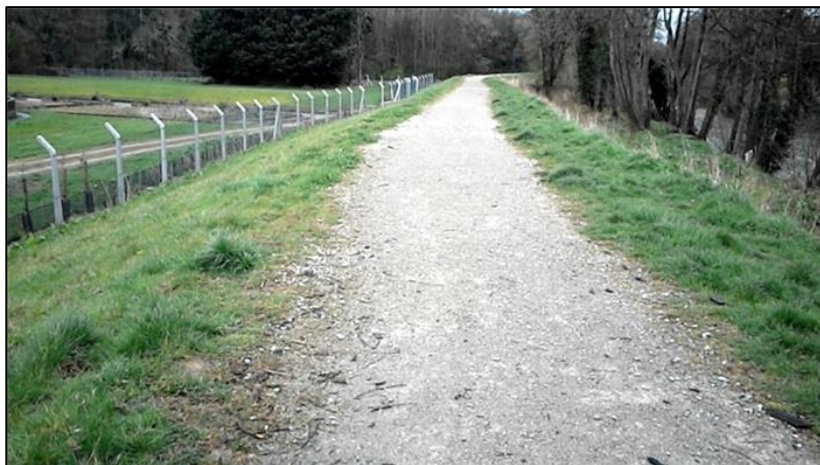
Figure 27: St Asaph STW Embankment Visual Inspection 2019 (NRW)

of the FDL. The upstream end of the embankment ties into high ground at the A55 flyover with a finished ground level of 14.06m AOD which forms FDL for the 0.5% AEP event.

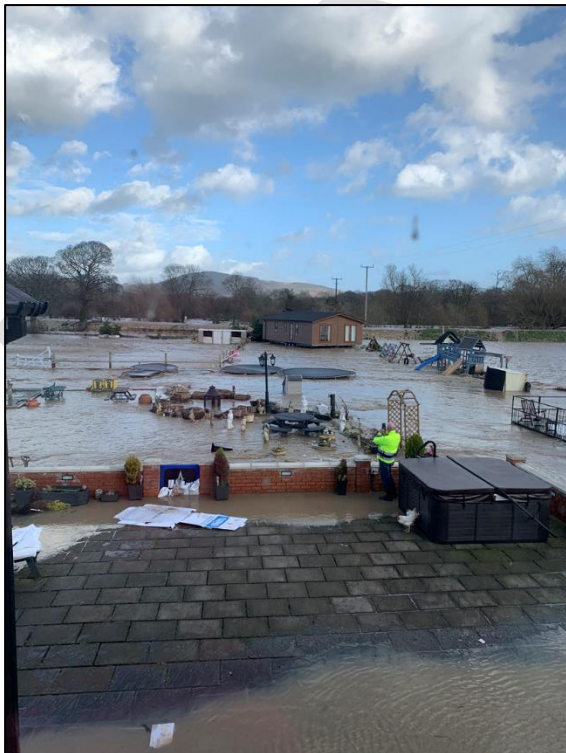
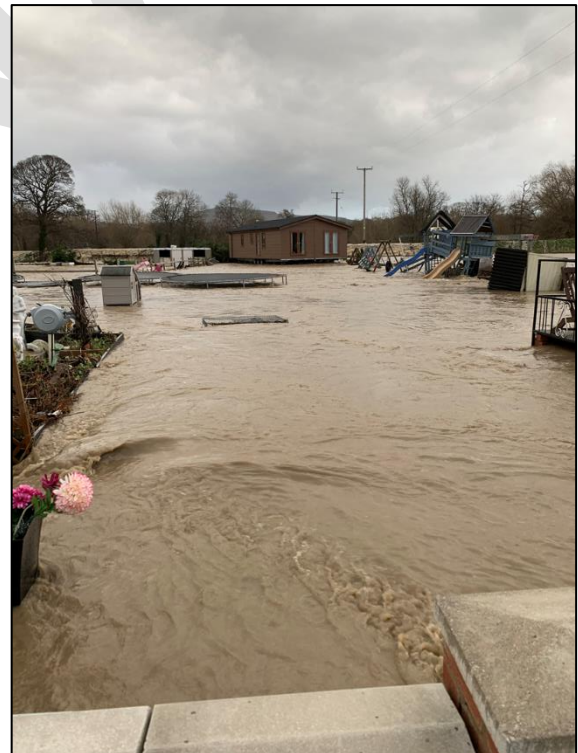
Initial reports from NRW operatives on site stated that flooding began to occur just downstream of Spring Gardens Bridge on the left bank (See Figure 35, Figure 34 & Figure 36), but based on observed water levels (Figure 31) it is possible other areas of raised defence in the lower reaches (downstream of Spring Gardens Caravan Park) of the Elwy started to overtop before this. Multiple sources later confirmed that during the event significant lengths of the Elwy Fishermans Bridge Embankment (EMB1500412) experienced overtopping, >200mm for approximately 1.5 hours (see Figure 32 & Figure 33 below).

Figure 32: Extensive embankment overtopping at Dol Afon (Elwy resident, 2020)

Figure 33: Extensive embankment overtopping at Dol Afon (Elwy resident, 2020)

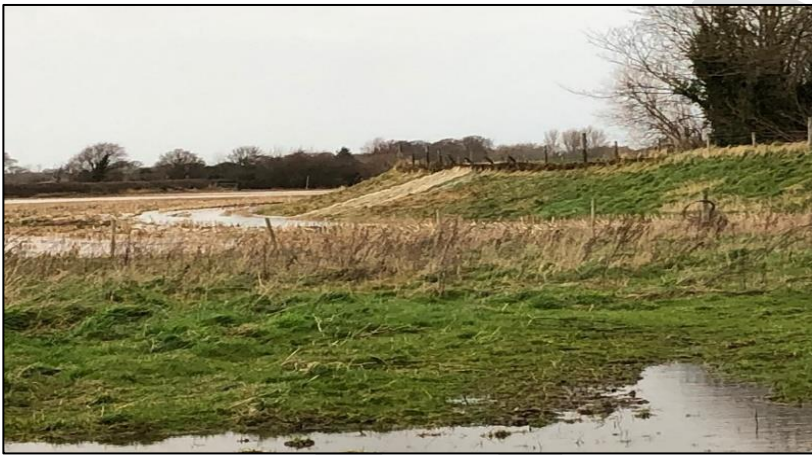
Figure 36: Phase 3 - Minimal overtopping at EMB1500412 (NRW 2020)

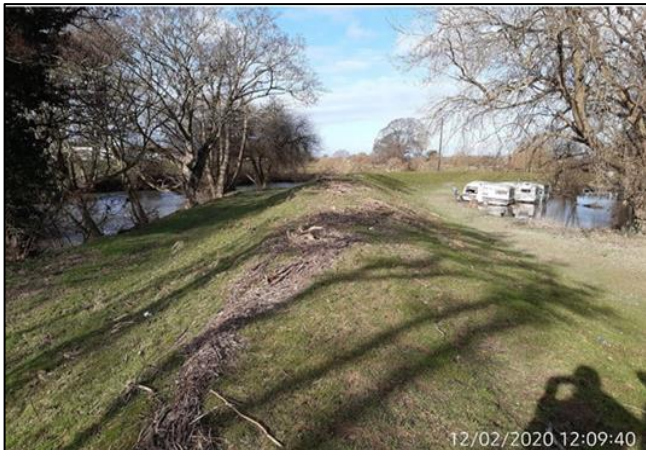
*Figure 38: Wrack & debris deposits showing line of overtopping (NRW, 2020)*

Recommendation 1.3 – NRW – All photos taken during formal NRW duties (inspection, maintenance, incident response etc.) should be time and date stamped.

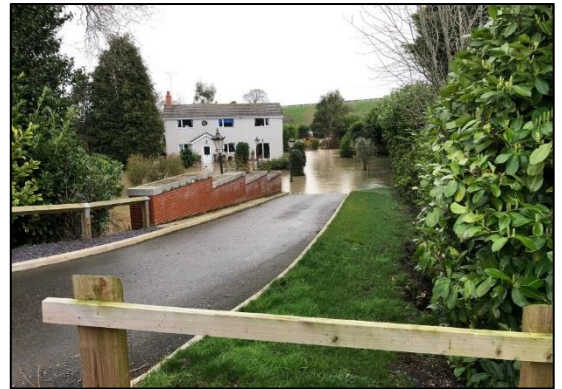
Significant overtopping, between 100-150mm over 150m for approximately 1.0 hour was observed on the right bank St Asaph STW Embankment (EMB1800067). A private residential dwelling (Figure 42) and 3 static caravans were inundated by flood water in the Spring Gardens Caravan Park (Figure 41). Significant amounts of water which overtopped the right bank flowed through the sewage treatment works, following the topography and filling the land of Spring Gardens Caravan Park. As the overtopping water could not exit the caravan park because of downstream embankments, depths within the park rose considerably. Although there is a small, privately owned pumping station on-site to drain surface water, there is no permanent infrastructure on site to evacuate the volume of water observed.

Figure 42: Residential property flooded on Elwy RB (NRW, 2020)

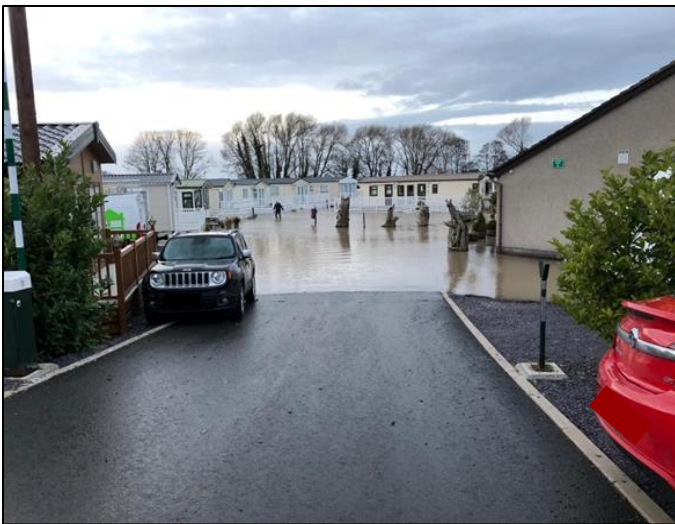
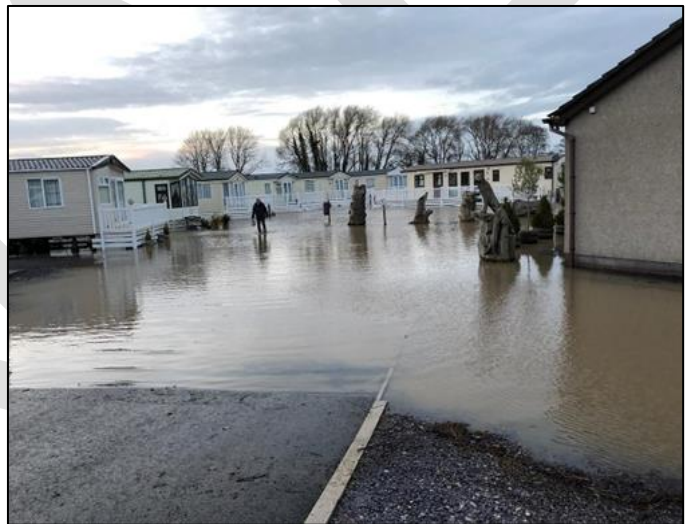
Figure 41: Spring Gardens Caravan Park flooding (NRW, 2020)

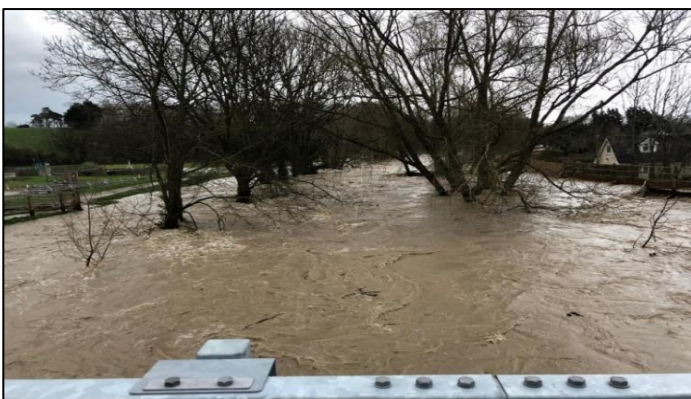
Initial investigations into the factors which caused the overtopping at this location pointed to the main reason being channel exceedance (Figure 43) due to a significant storm event affecting the upper catchment. It is probable that hydraulic afflux (localised raising of water levels) occurred in the immediate vicinity of the STW embankment due to the dense, mature trees on the riverbank berm. Water levels may also have increased locally due to super elevation caused by the volume of water passing around a slight

bend in the river channel at this location. A build-up of debris in the channel profile impacting available cross-sectional area and reducing conveyance efficiency may also have exacerbated water levels but it is difficult to ascertain the full impact due to the high debris loading already in the system during high flow events.

Figure 43: Elwy river levels 09-02-2020 (NRW, 2020)

Recommendation 2.1 – NRW – Undertake a performance review for the 2018 St Asaph Flood Risk Management scheme.

Recommendation 2.2 – NRW – Using the hydraulic model, investigate the flow mechanisms and sensitivity of various parameters which may be impacting water levels at St Asaph STW Embankment.

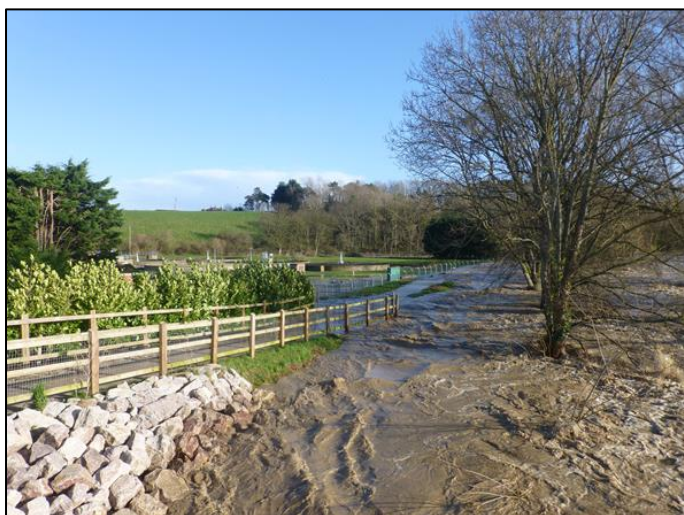
Overtopping of the St Asaph STW Embankment started after the defences in Lower St Asaph had been overtopping for a period of time (Figure 45). During the post-event topographic survey, a low spot (approx. 100mm) was identified over a short length, less than 5m, of the right bank. Information and photographs obtained through the subsequent investigation have found evidence to show that overtopping occurred along a significant length of the right bank (Figure 44). Although observed to be extensive and prolonged, the overtopping was not deemed to pose a significant risk of defence failure during the event based on age, build quality and current condition. Post-event asset inspections (Figure 48) confirmed that the embankment structure had performed well under considerable hydraulic and debris loading.

Figure 45: Water levels looking u/s from SGB (Resident photo)

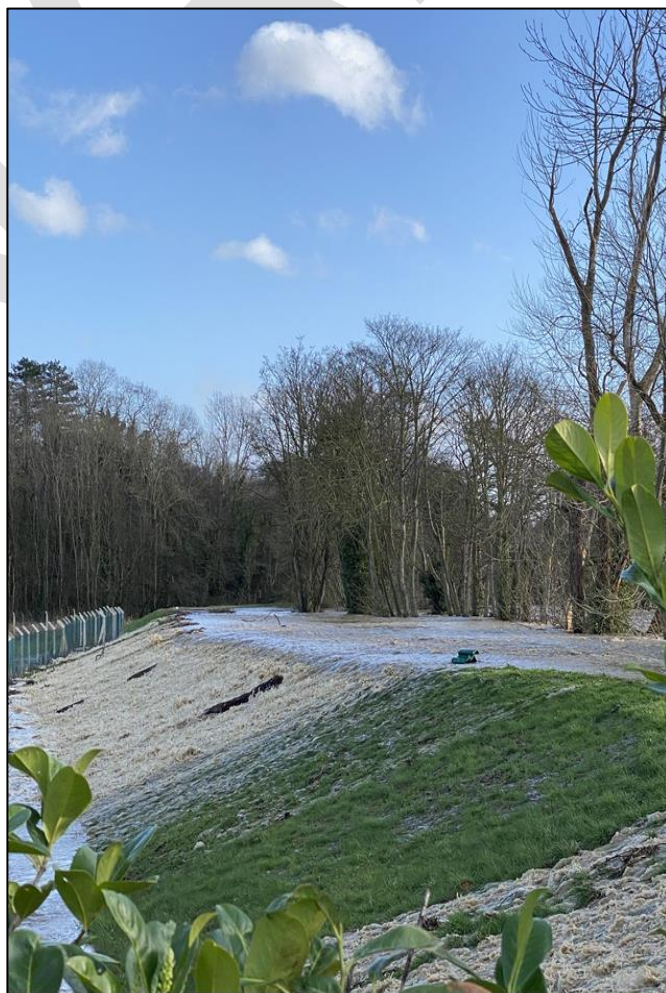
Figure 44: Overtopping of RB EMB1800067 (Resident Photo)

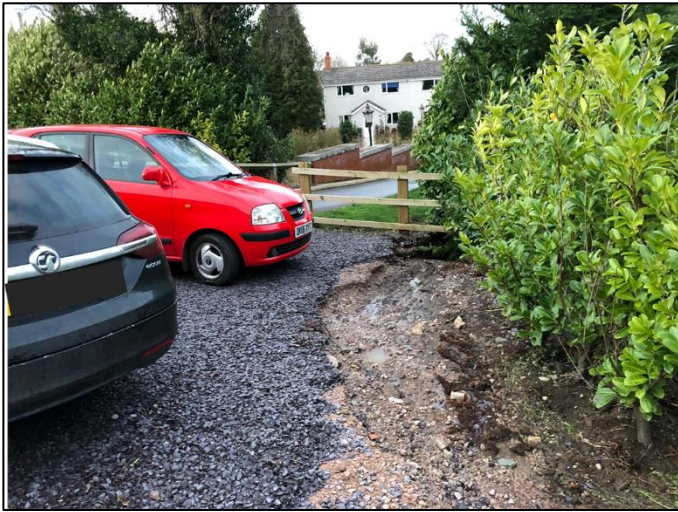
There was one area of minor scour (Figure 46), later observed to be in the approximate location of the low spot. The scour observed only at this specific location and not on the embankments is likely due to a concentrated flow route, turbulence caused at the base of the hedge and lack of grass revetment.

Figure 46: Localised scour caused by overtopping at the discrete low spot (NRW, 2020)

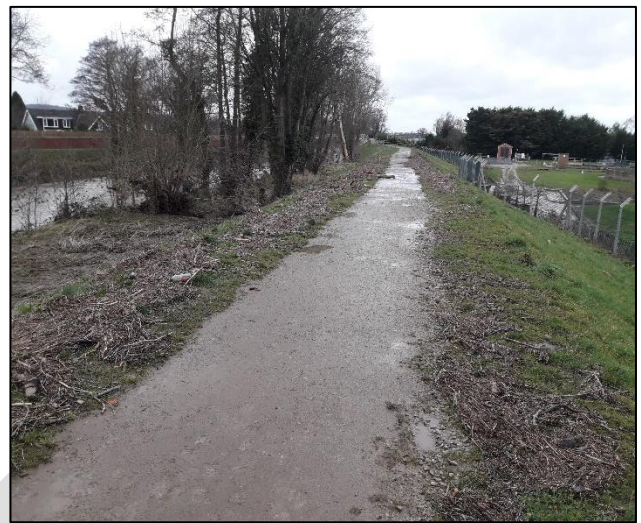
Figure 47: Line of wrack on RB STW emb (NRW, 2020)

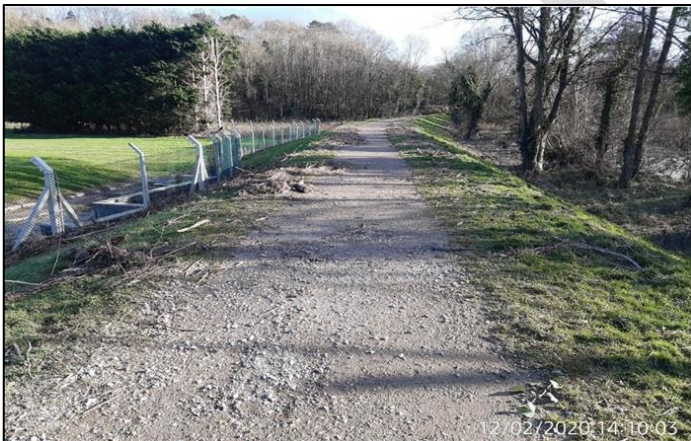
Figure 48: Post Event Inspection RB EMB1800067 (NRW, 2020)

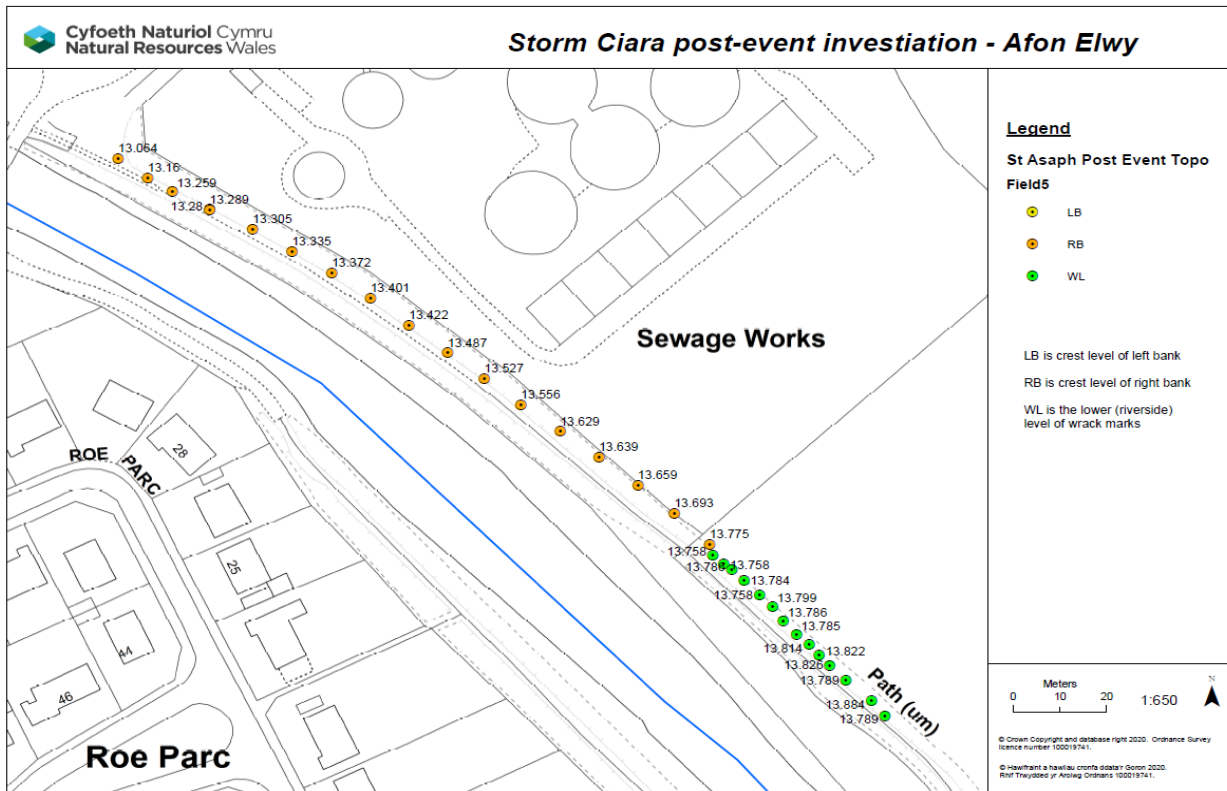
Investigations and survey collected in the days after the event found a number of wrack (flood debris) marks, silt lines and flattened vegetation which allows for anecdotal evidence obtained during the event to be validated. Wrack marks on the right bank show a clear line at which overtopping occurred (Figure 47). Post-event topographic survey showed that overtopping started at approximately 13.693m AOD on the right bank (Figure 49). The map shows green dots where wrack was deposited on the riverside slope or crest of the embankment and orange dots are embankment crest levels at which overtopping was confirmed to have occurred.

Figure 49: Post-event topographic survey (NRW, 2020)

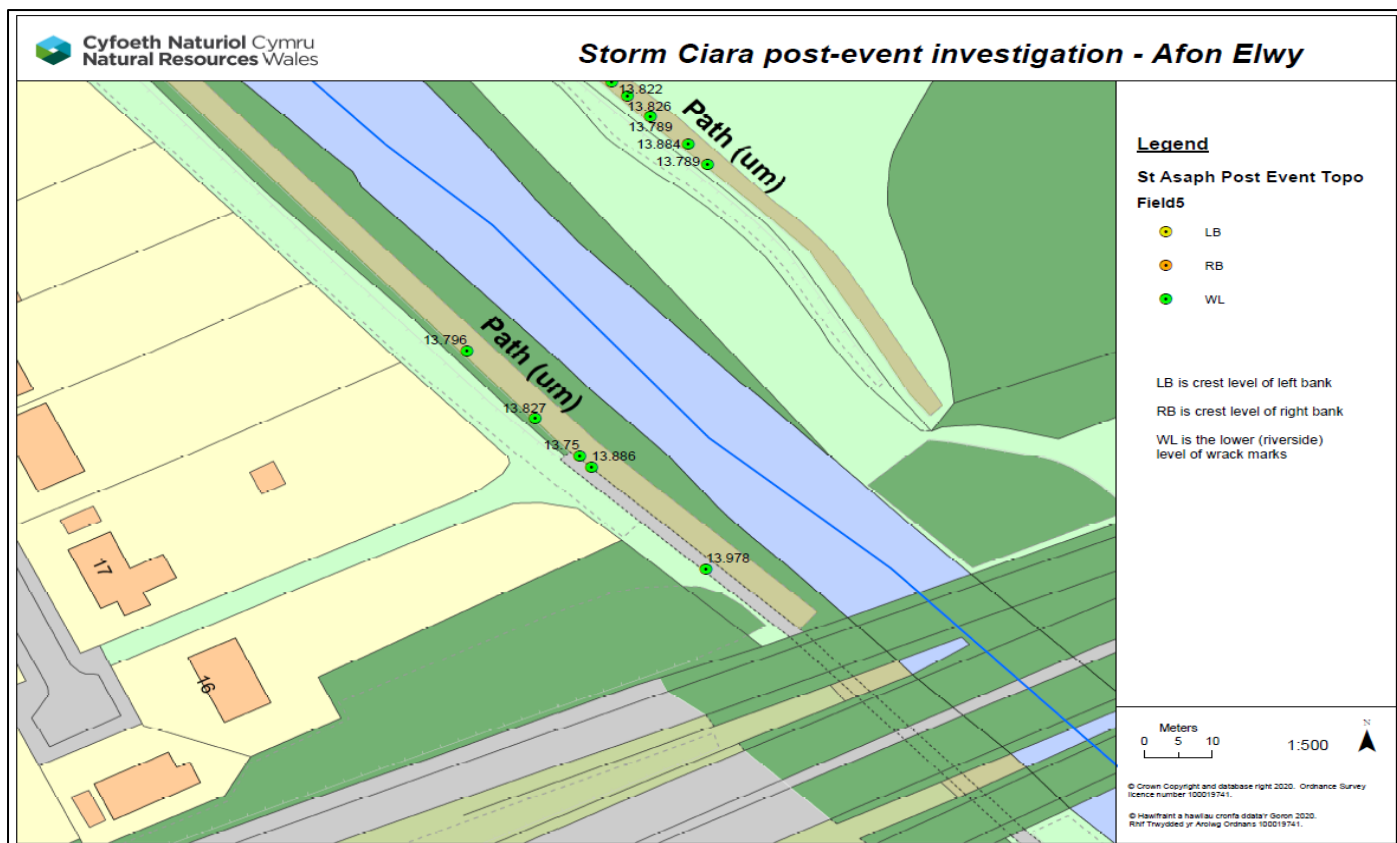
Figure 55: Left bank recorded wrack marks (NRW, 2020)

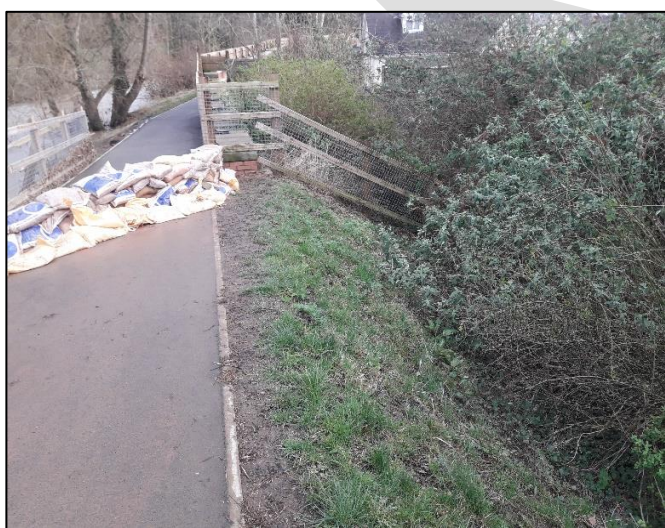
Figure 56: Sandbags placed at Roe Parc wall by residents (NRW, 2020)

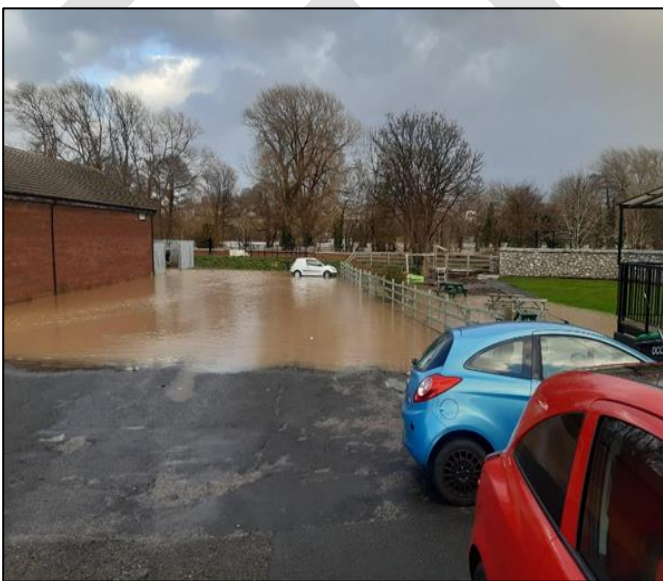
Water flowed over the left bank of Glascoed stream and spread across the road impacting highways and properties and flooding one residential property internally. The water continued to flow down the B5381, over the ramp and into the New Inn car park where depths increased (Figure 59) due to the Elwy embankments not allowing water back into the river. The Oaks residential property was flooded internally to approximately 50-100mm. The lower, uninhabited floors of the New Inn Public House were inundated from floodwaters which flowed down the road from Glascoed Stream causing damage to appliances and stock. The lower floors of the gym building were inundated but the depth of water and extent of damage is unknown at the time of writing.

*Figure 59: Water accumulation behind embankment at New Inn (NRW, 2020)*

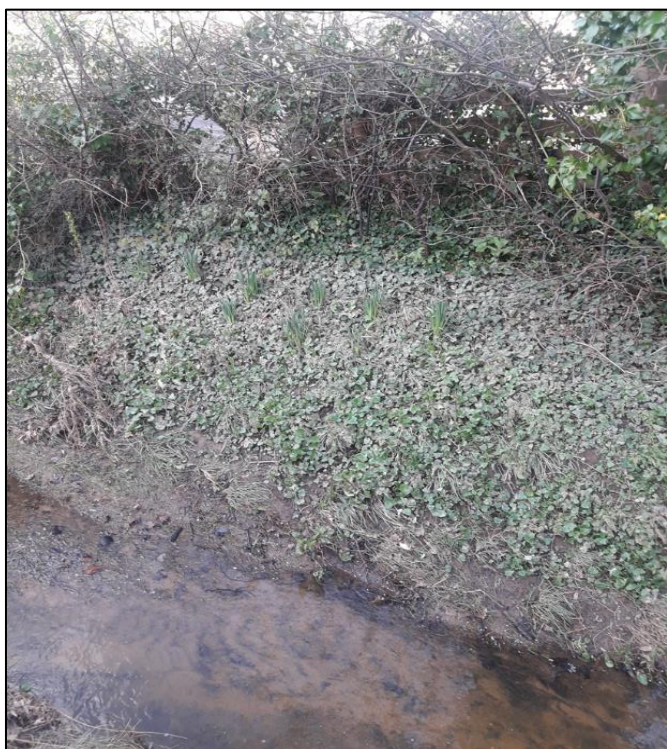
Post event inspection of the Glascoed Stream by representatives of NRW and DCC highlighted the high-water levels (Figure 62). During the event residents utilised available material to divert flood water away from property and into road gulleys and surface water systems (Figure 61 & Figure 60).

Figure 62: Silt mark Glascoed Stream (NRW, 2020)

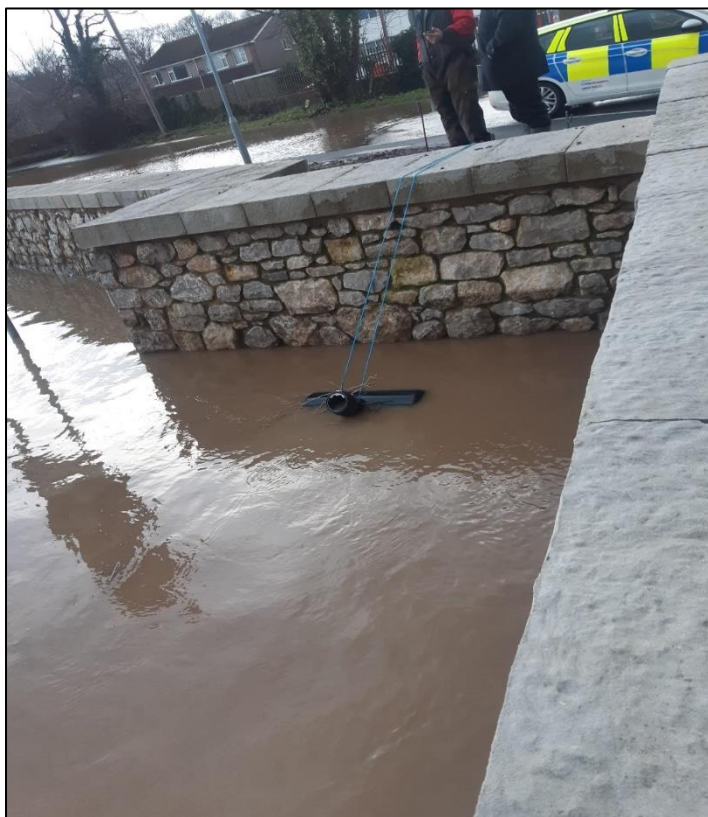
At some time during the event, unauthorised opening of the flap valve took place (Figure 63), and although water levels within the Glascoed Stream were high, backflow from the Afon Elwy would have exacerbated the situation. It must be understood that flood defence assets are designed to a specification with strict operating regimes, and any unauthorised operation of such assets can be extremely detrimental to people, property and infrastructure and potentially life threatening.

Figure 63: Unauthorised opening of non-return valve (NRW, 2020)

**Recommendation 4.1 – NRW – Model the effects of non-return flap operation on water levels in the Glascoed Stream.**

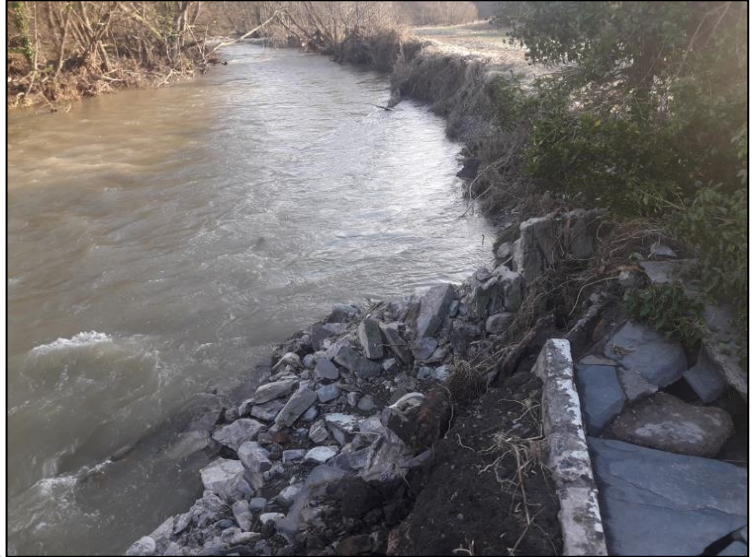
Figure 68: Erosion to private garden, showing historic riverbank revetment (NRW, 2020)

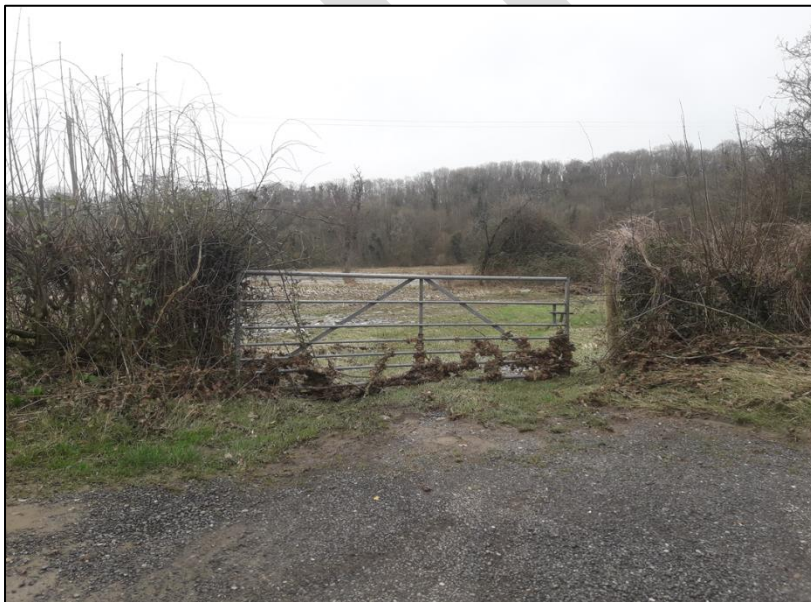
The Elwy at Mill Cottage community has a wide floodplain contained on the left bank by high ground, flood depths through this section can be significant (Figure 69). There are four residential properties at Mill

Figure 69: Wrack mark on gate showing height of flood (NRW, 2020)

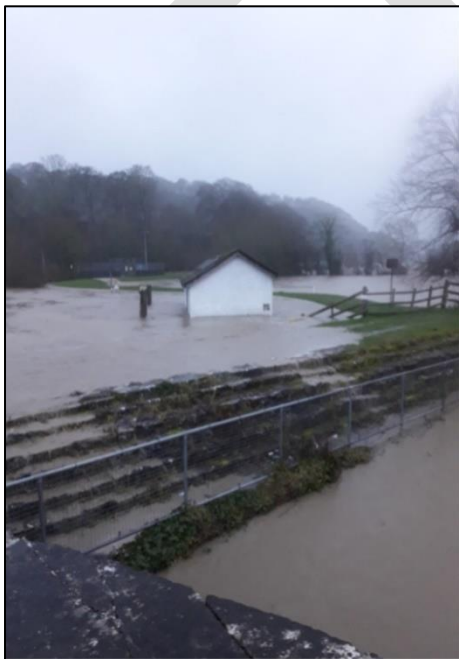
Figure 77: Overtopping Llanfair TH Elwy embankments back into the Elwy (Resident photo)

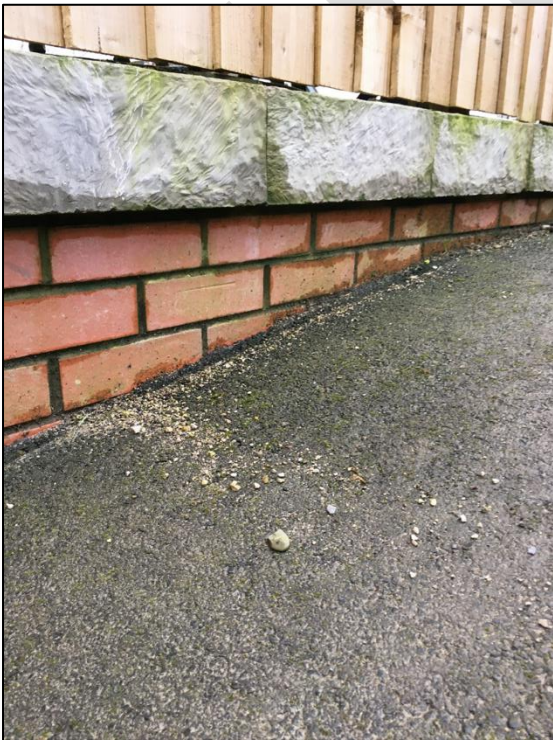
*Figure 90: River gravel deposit on Foxons Ramp (NRW, 2020)*

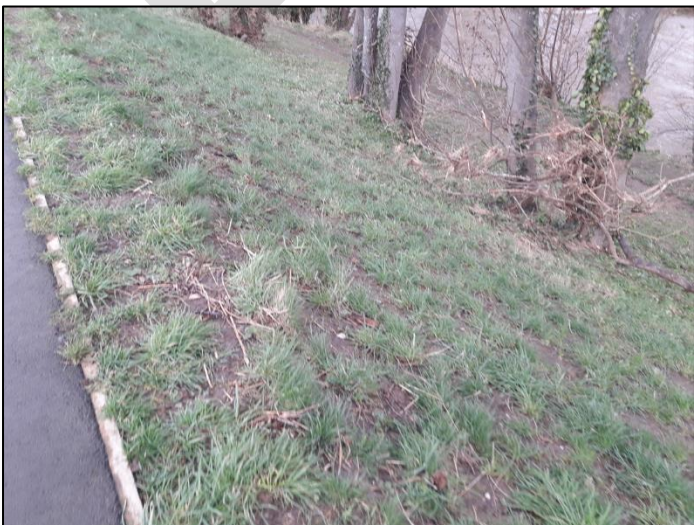
Figure 101: Wrack marks u/s library wall (NRW, 2020)

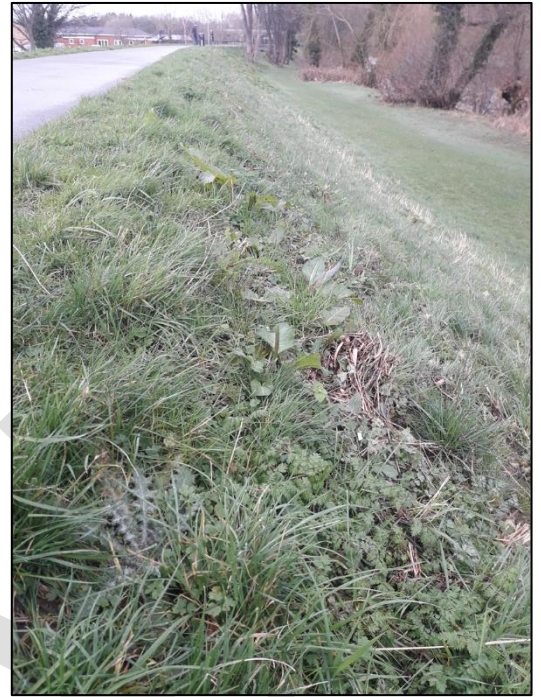
Figure 103: Wrack marks Dr Emb (NRW, 2020)
