# **Flood Investigation Report**

## **St Asaph and Elwy Communities**

Storm Ciara  
9<sup>th</sup> February 2020

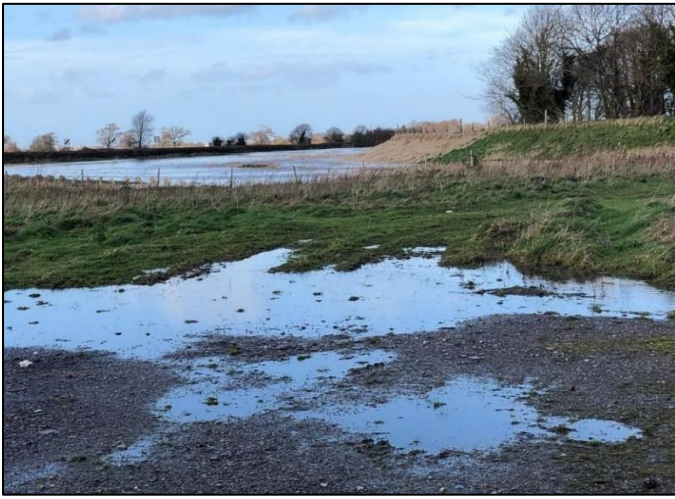
Initial reports from NRW operatives on site stated that flooding began to occur just downstream of Spring Gardens Bridge on the left bank (See Figure 35, Figure 34 & Figure 36), but based on observed water levels (Figure 31) it is possible other areas of raised defence in the lower reaches (downstream of Spring Gardens Caravan Park) of the Elwy started to overtop before this. Multiple sources later confirmed that during the event significant lengths of the Elwy Fishermans Bridge Embankment (EMB1500412) experienced overtopping, >200mm for approximately 1.5 hours (see Figure 32 & Figure 33 below).

Figure 34: Phase 1 - Extensive overtopping at EMB1500412 (NRW 2020)

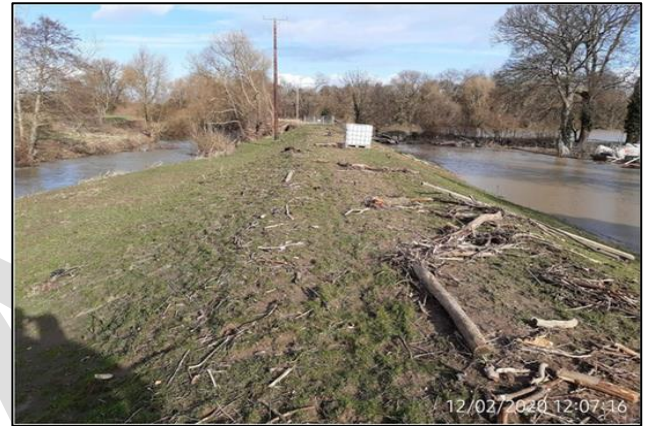
*Figure 37: Wrack & debris deposits signifying overtopping location (NRW, 2020)*

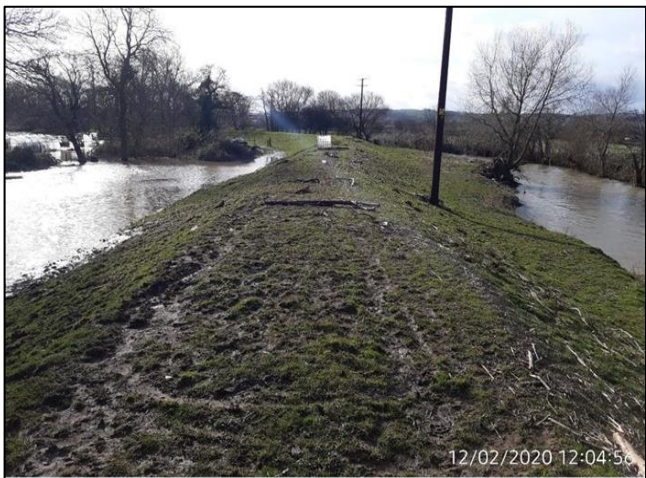
*Figure 39: Wrack & debris deposits on the riverside face (NRW, 2020)*

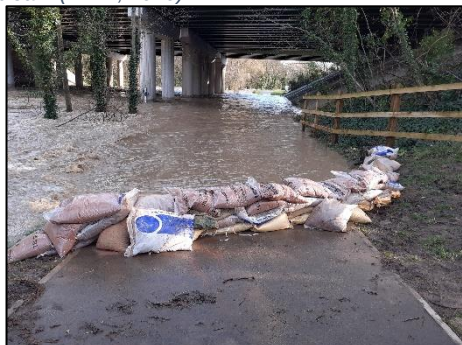
Figure 53: Sandbags placed at Roe Parc by residents looking upstream (Resident photo, 2020)

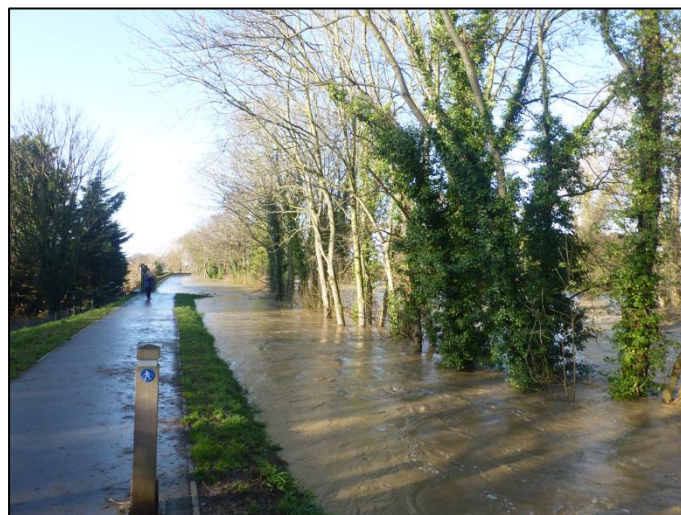
Water levels on the left bank (Figure 55) just downstream of the A55 flyover reached 13.978m AOD as the velocity of water pushed up the smooth surface of the tarmac footpath. Water levels on the left bank at the upstream end of Roe Parc Wall reached 13.886m AOD. Residents deployed sandbags (Figure 52) to stop water being pushed up the tarmac path and over the bank towards Roe Parc. Based on evidence provided by residents and flood wardens and validated by post-event survey, it is unlikely that river levels (Figure 54) would have overtopped the Roe Parc embankment just downstream of the A55 bridge.

Figure 54: Water levels at u/s end of Roe Parc Wall (Resident photo)

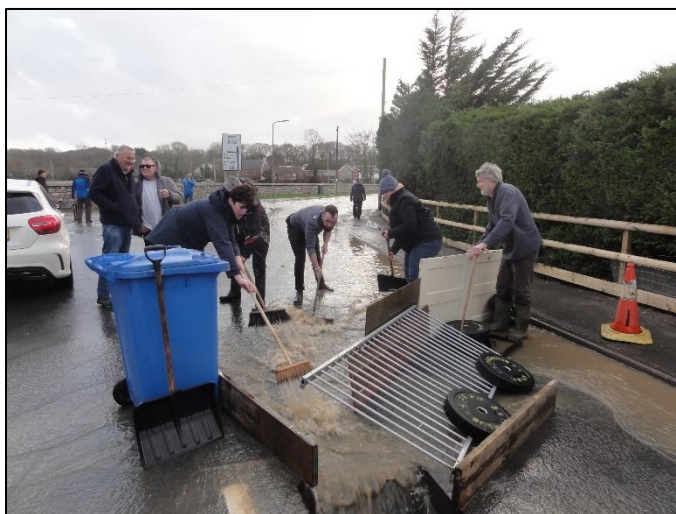
Figure 61: Residents diverting flood waters from Llwyn Elwy during Storm Ciara (Resident Photo, 2020)

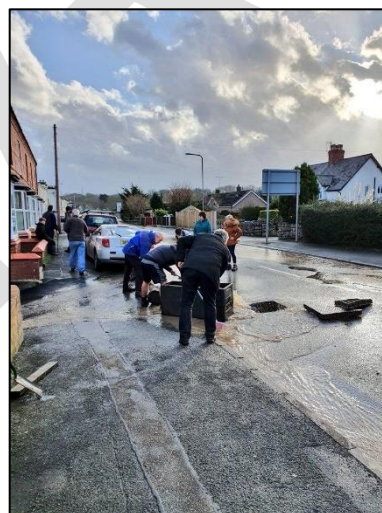
Figure 60: Residents diverting flood waters on Lower Denbigh Road during Storm Ciara (Resident Photo, 2020)

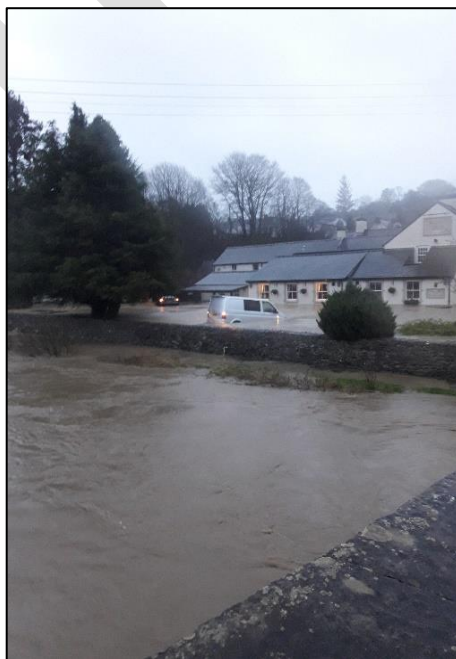
The river levels on the Elwy recorded downstream at Pont Y Gwyddel were the highest ever observed, along with significant rainfall totals recorded at Gwytherin rain gauge upstream of Llanfair TH, point to a significant event on the Afon Elwy (Figure 76) which exacerbated flood water levels in lower areas of the Llanfair community. During the 2012 flood event, anecdotal evidence highlighted a flow route from the Afon Elwy crossing agricultural land (natural floodplain) and entering Llanfair community along School Lane from west to east. This same flow route was observed by a Llanfair resident and flood warden during the 2020 event. Based on this information and the location and height of flood defences, it is surmised that this flow route is only initiated during flow events significantly greater than 1 in 100 year (1% AEP) on the Afon Elwy. Flood levels in the lower village were significant, greater than 1m in areas, as a result of culvert exceedance of the Nant Barrog and natural channel exceedance of the Afon Elwy. The significant flood levels are demonstrated by Figure 77 which shows flood water in lower Llanfair overtopping the Elwy embankments back into the Elwy floodplain. The wall in front of the Black Lion Hotel was also overtopped by flood water back into the Elwy.

Figure 76: Flooding in Llanfair TH (Resident photo)

Recommendation 7.1 – NRW – Investigate through computational modelling the flow mechanisms from both the Nant Barrog and Afon Elwy, impacting Llanfair Talhaiarn Community in significant flood events.

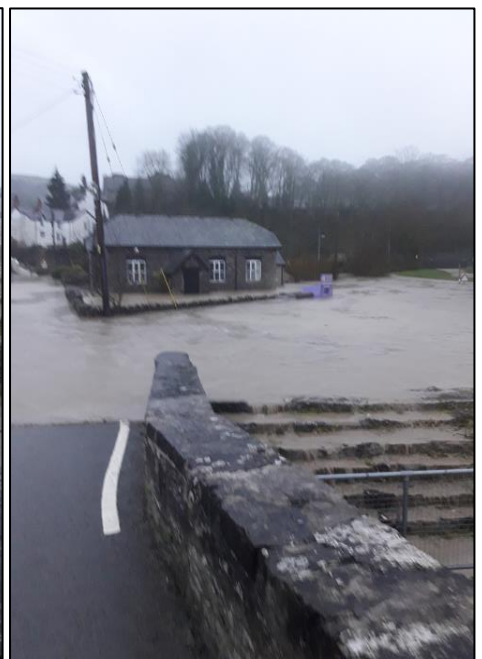
Figure 75: Flooding in Llanfair TH exacerbated by Elwy river levels (Resident photo)

The Black Lion Hotel and Glyndwr Hall were flooded to significant depths by the Nant Barrog and exacerbated by inundation from the Afon Elwy. A number of other residential and commercial properties along Water Street were also flooded by flows from the Nant Barrog.

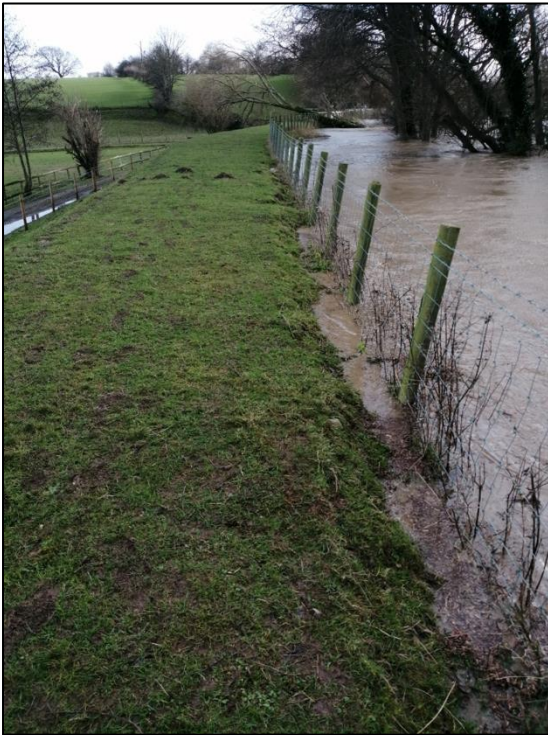
*Figure 88: River levels d/s of fishermans bridge (NRW, 2020)*

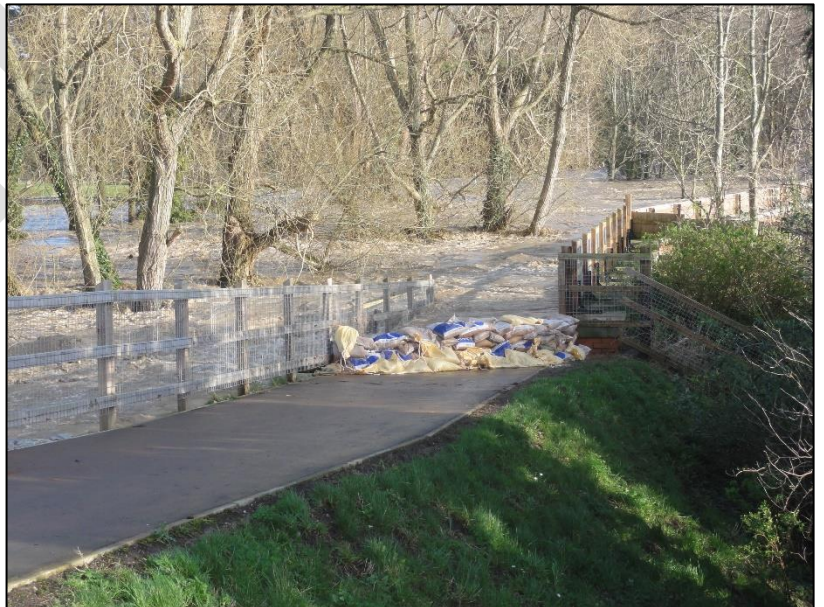
*Figure 89: Sandbags deployed at Roe Parc Wall (Resident photo, 2020)*

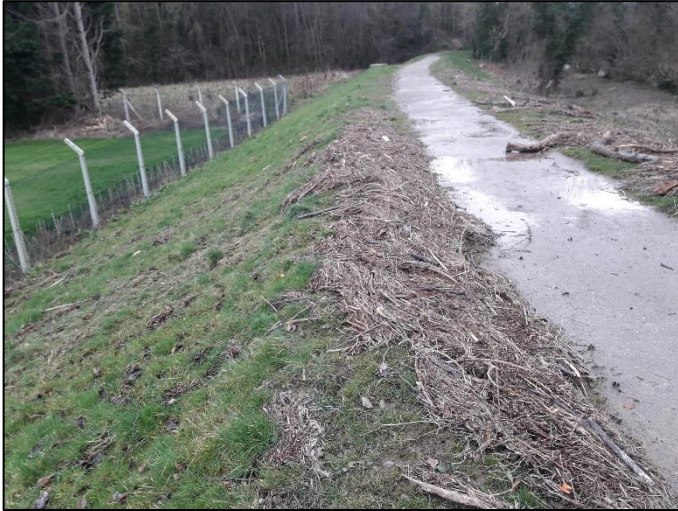
Figure 94: Overtopping location RB STW emb (NRW, 2020)

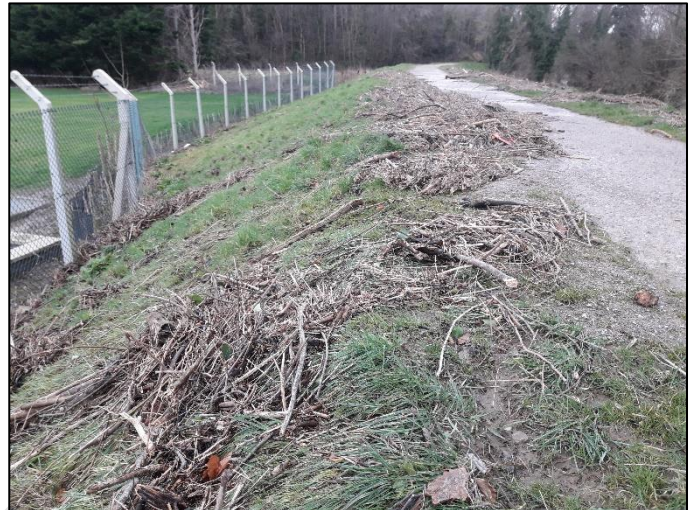
Figure 91: Overtopping location RB STW emb (NRW, 2020)

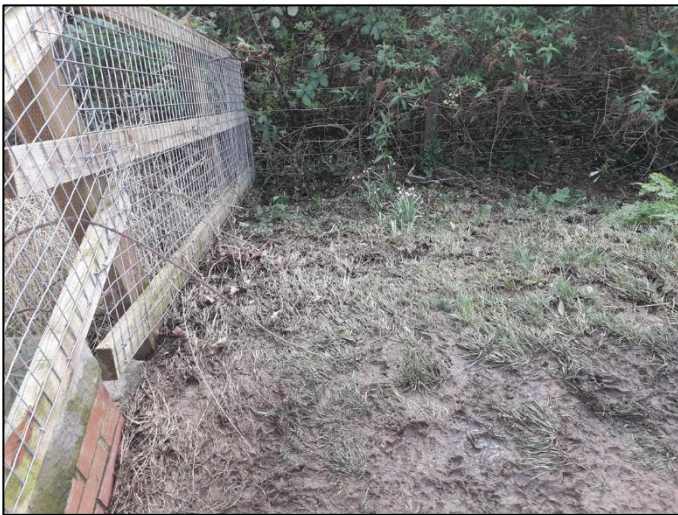
Figure 93: Location of overtopping Roe Parc Wall (NRW, 2020)

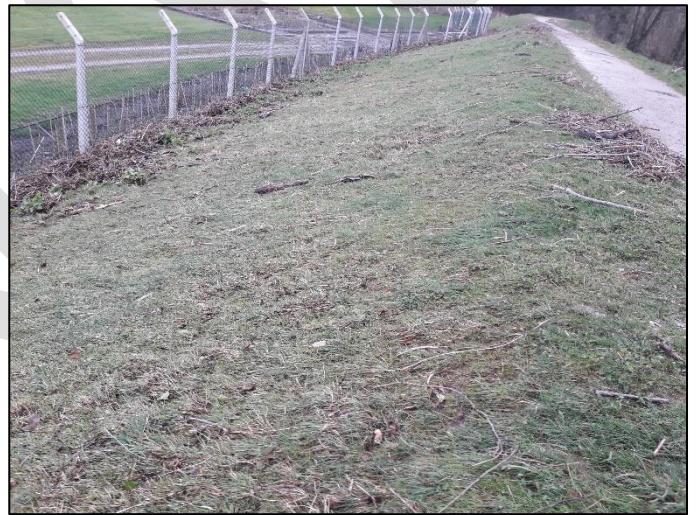
Figure 92: Overtopping location RB STW emb (NRW, 2020)

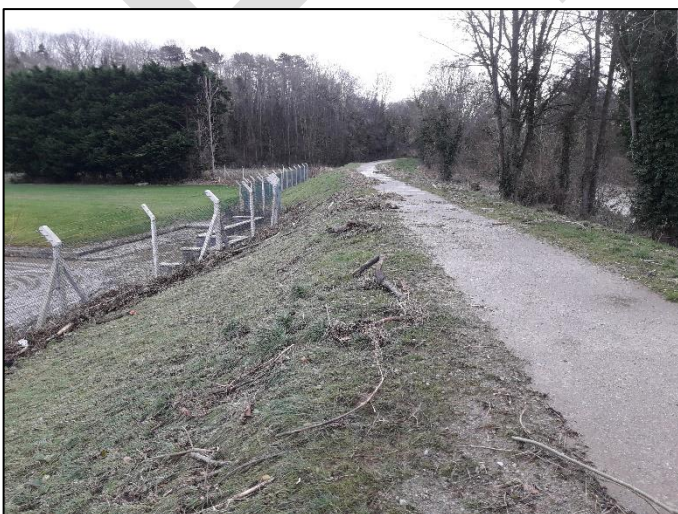
Figure 96: Progression of overtopping RB STW emb (NRW, 2020)

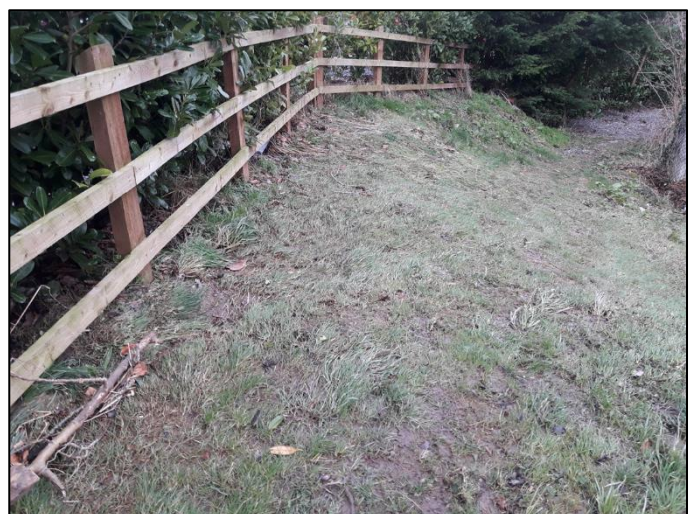
Figure 95: Overtopping location RB STW emb (NRW, 2020)

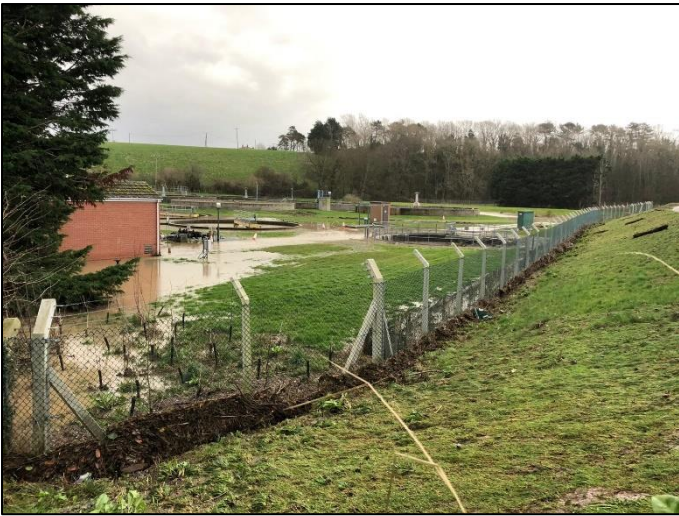
Figure 100: Post event debris (Resident photo)

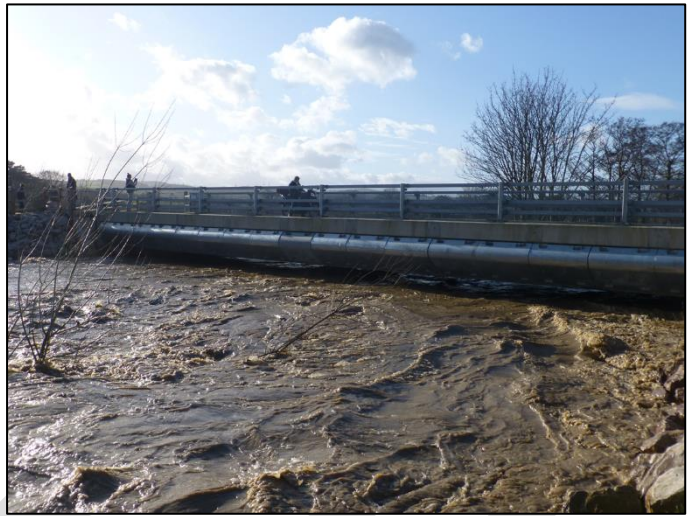
Figure 99: Water levels at SGB (Resident photo)

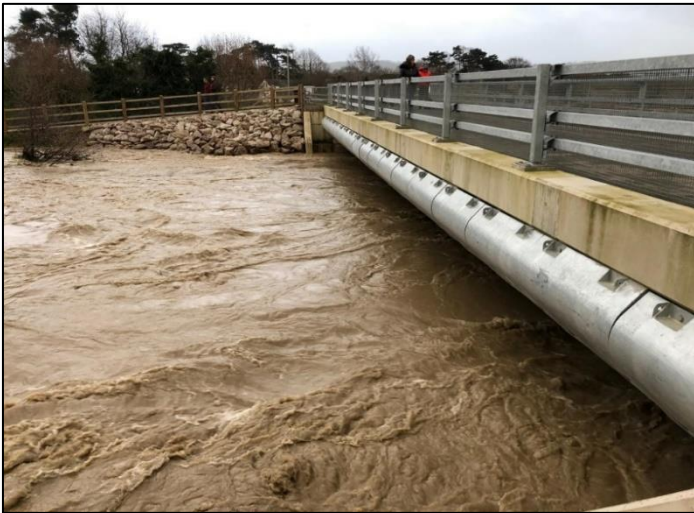
Figure 97: River levels 09-02-2020 compared to bridge deck (NRW, 2020)

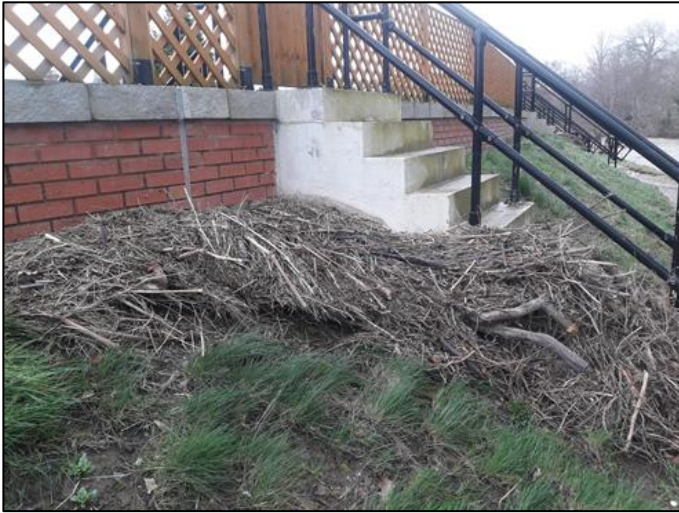
Figure 104: Flood debris at the rear of Ruby Terrace (NRW, 2020)

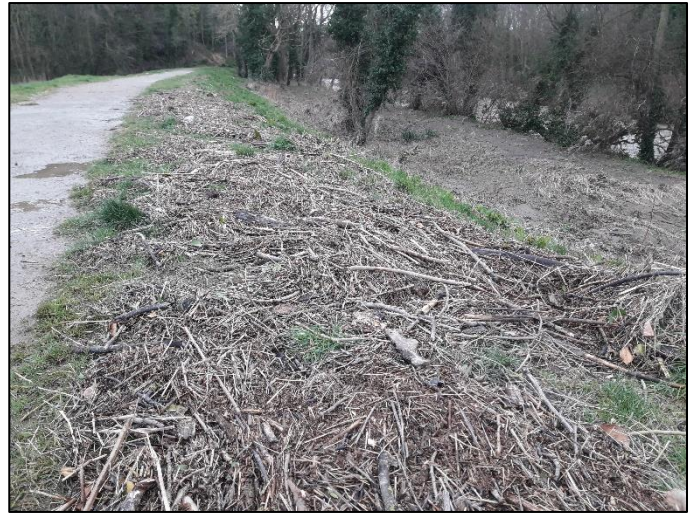
Figure 108: Overtopping location RB STW emb (NRW, 2020)

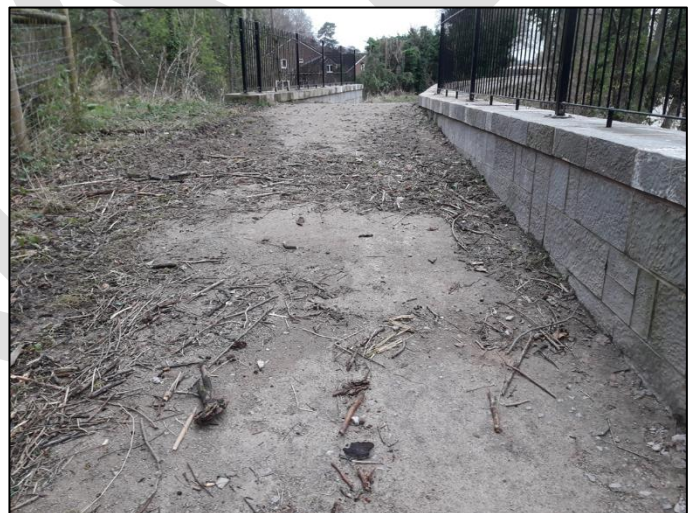
Figure 111: Wrack marks at Pont Begard wall (NRW, 2020)

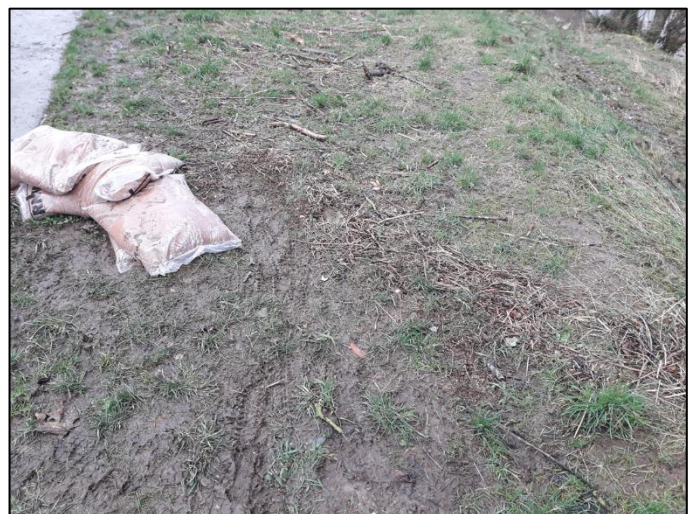
Figure 109: Wrack marks at Roe Parc emb (NRW, 2020)

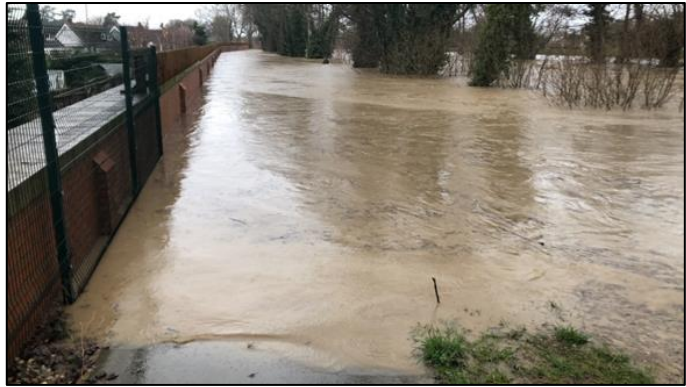
Figure 113: Water mark d/s Pont Begard (NRW, 2020)

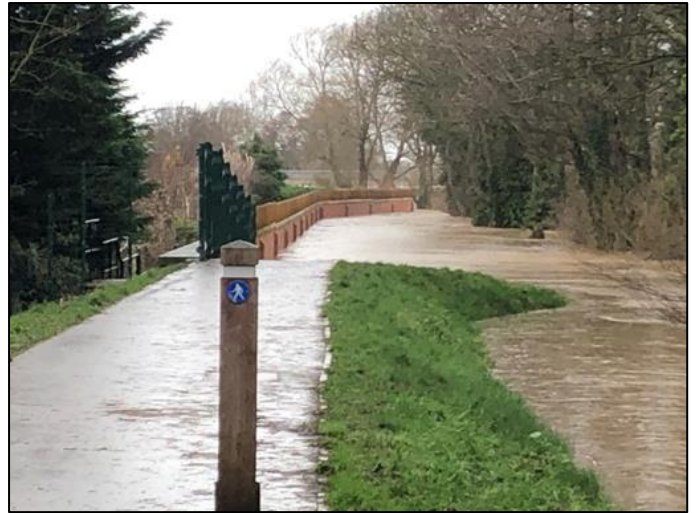
Figure 117: Prior to peak water levels at A55 birdge (Resident photo)

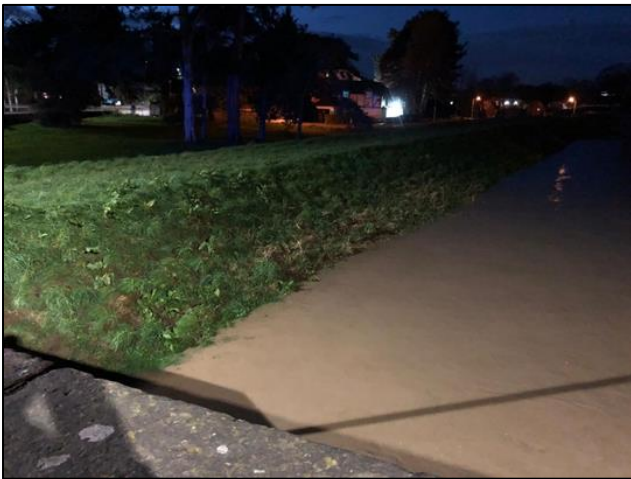
Figure 116: Prior to peak water levels at u/s end of Roe Parc Wall (Resident photo)

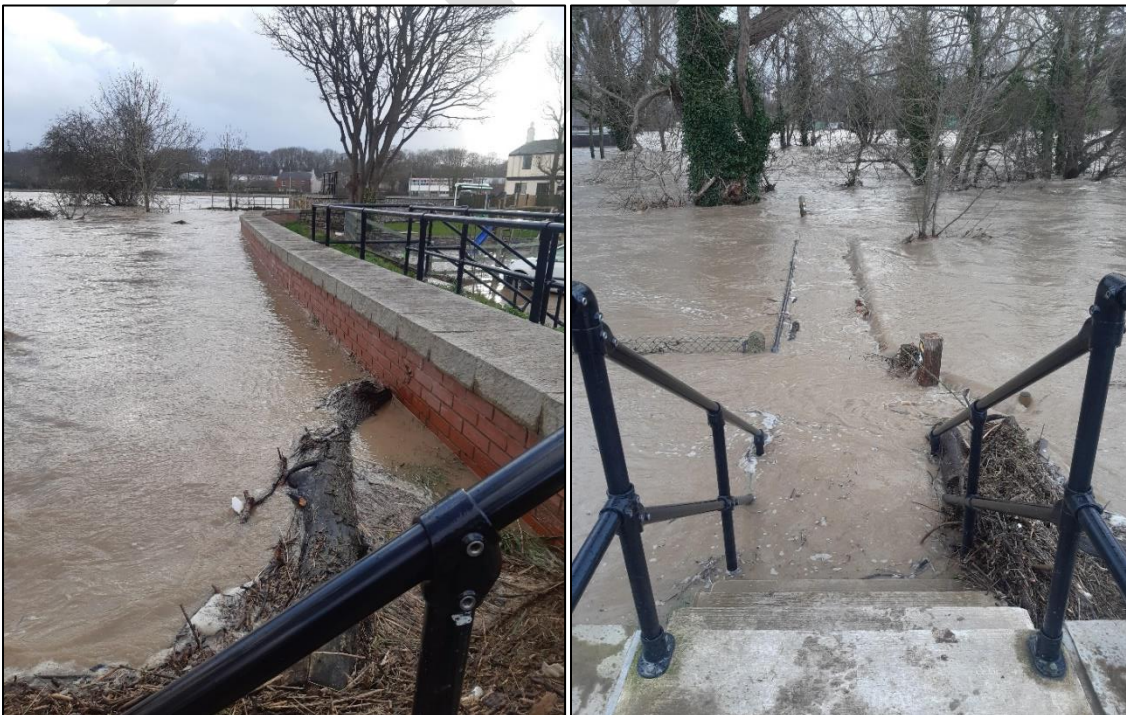
Figure 118: River levels at confluence of Glascoed & Elwy (NRW, 2020)
