# **Flood Investigation Report**

## **St Asaph and Elwy Communities**

Storm Ciara  
9<sup>th</sup> February 2020

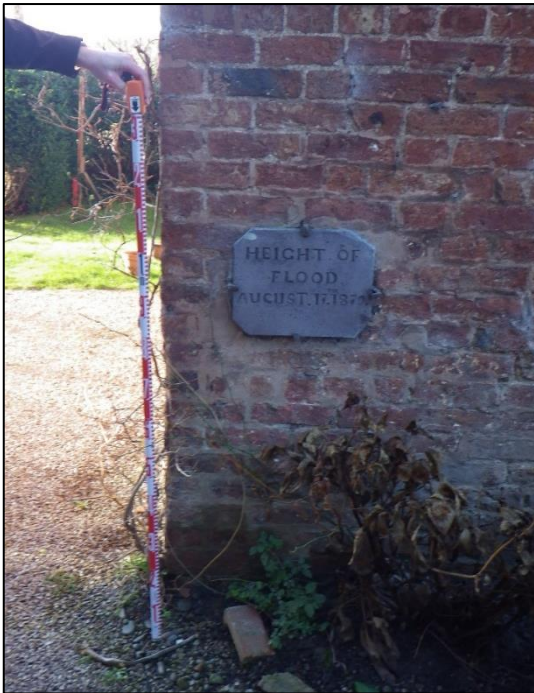
There is a long history of flood events, of varying magnitude, observed within the Elwy catchment, many of which have occurred in recent history. A plaque on the Laundry Cottage St Asaph states 'Height of Flood August 17<sup>th</sup> 1879', positioned approximately 700mm from ground levels

Figure 4: Plaque on Laundry Cottage, St Asaph

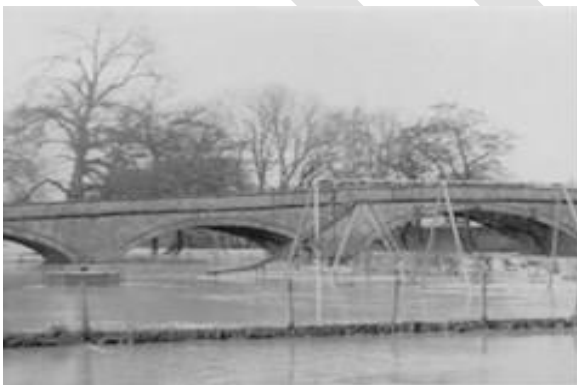
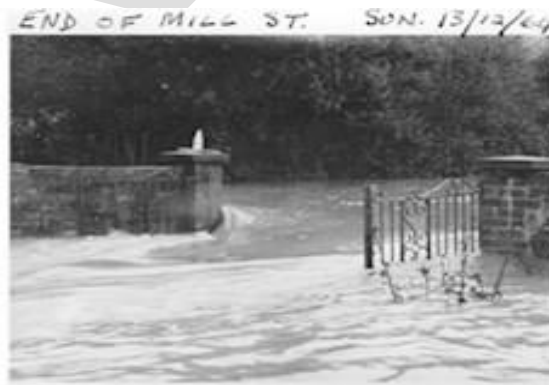
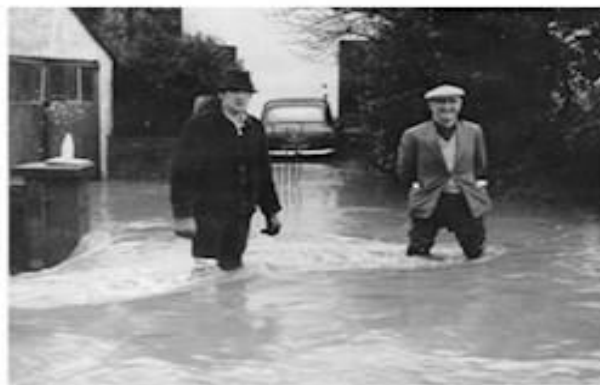
Although details are scarce, flooding is known to have impacted the City of St Asaph in 1964 when channel capacity was exceeded; although records do suggest properties on Lower Denbigh Road were not flooded internally. The 1964 event occurred before the construction of any formalised, raised, flood defences in the confines of the main residential areas of the city. Flooding is also known to have impacted the Elwy floodplain upstream of St Asaph in 2000, but again details of properties affected are minimal.

Figure 5: Historic photographs; flooding on the Elwy circa 1964 (Source unknown)

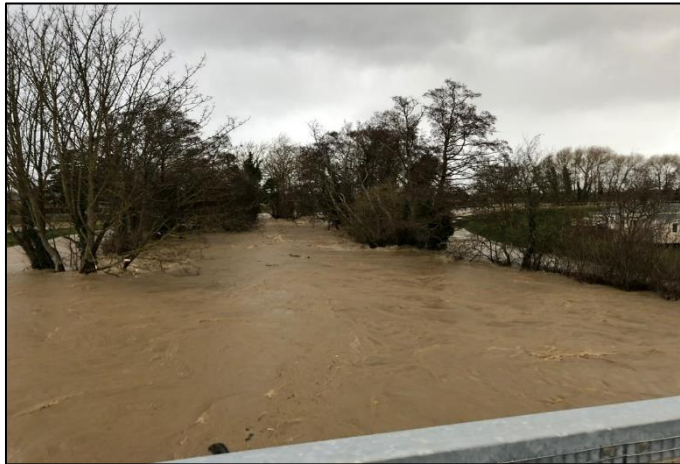
Initial reports from NRW operatives on site stated that flooding began to occur just downstream of Spring Gardens Bridge on the left bank (See Figure 35, Figure 34 & Figure 36), but based on observed water levels (Figure 31) it is possible other areas of raised defence in the lower reaches (downstream of Spring Gardens Caravan Park) of the Elwy started to overtop before this. Multiple sources later confirmed that during the event significant lengths of the Elwy Fishermans Bridge Embankment (EMB1500412) experienced overtopping, >200mm for approximately 1.5 hours (see Figure 32 & Figure 33 below).

Figure 31: Afon Elwy levels looking D/S from SGB (NRW, 2020)

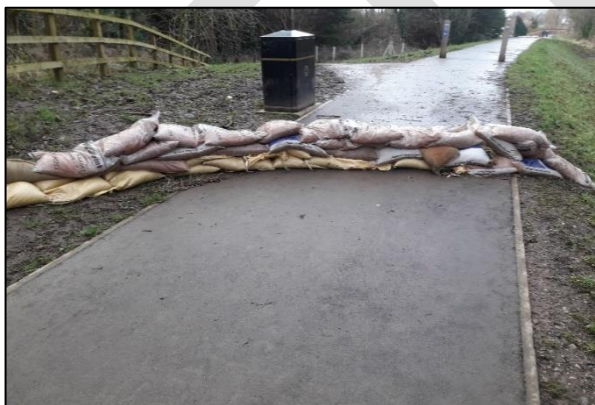
Water levels on the left bank (Figure 55) just downstream of the A55 flyover reached 13.978m AOD as the velocity of water pushed up the smooth surface of the tarmac footpath. Water levels on the left bank at the upstream end of Roe Parc Wall reached 13.886m AOD. Residents deployed sandbags (Figure 52) to stop water being pushed up the tarmac path and over the bank towards Roe Parc. Based on evidence provided by residents and flood wardens and validated by post-event survey, it is unlikely that river levels (Figure 54) would have overtopped the Roe Parc embankment just downstream of the A55 bridge.

Figure 52: Sandbags placed at Roe Parc by residents looking downstream (NRW, 2020)

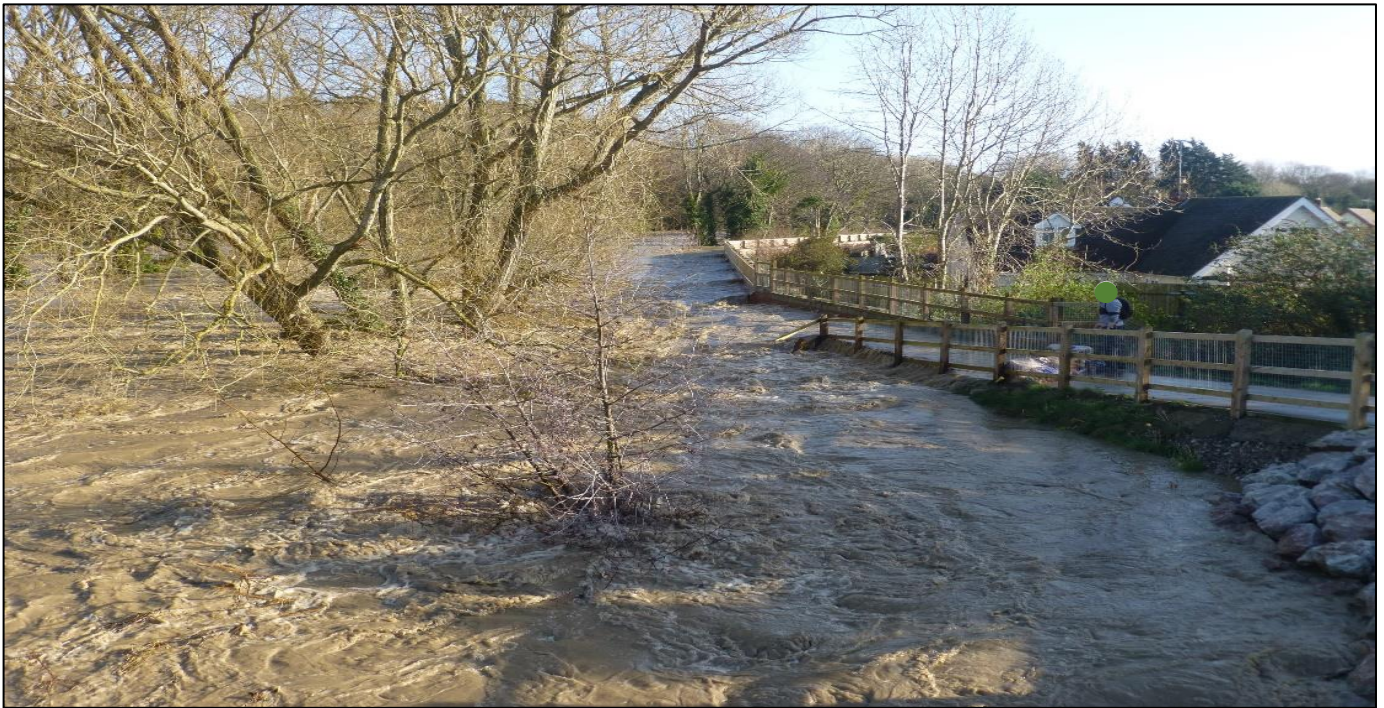
A Roe Parc resident estimated overtopping at the downstream end of Roe Parc Wall started when the manual river gauge located on the A55 bridge was reading 4.6m. Post-event investigation showed that overtopping started downstream of Spring Garden Bridge and was later observed to be pushing up smooth surfaces causing minor overtopping at Roe Parc when the manual river gauge was reading circa 4.8m. The photo below (Figure 57) was taken at the height of the flood when the manual river gauge under the A55 bridge was reading 4.9 metres. Overtopping was observed to be minimal before residents deployed sandbags (Figure 56). The role of flood

*Figure 57: River levels looking upstream from Spring Gardens Bridge (Source: Roe Parc Resident)*

**Recommendation 3.1 – NRW – Review policy and procedure regarding the roles and responsibilities of flood wardens both in an incident and during normal working times.**

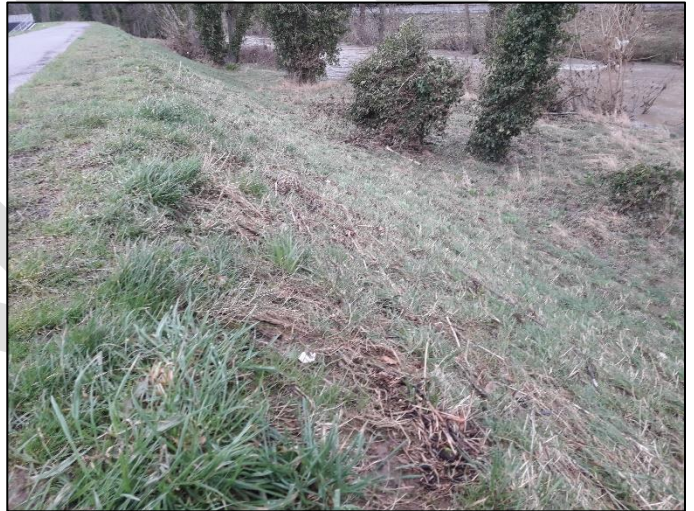
Figure 98: Wrack marks cattle market emb u/s section (NRW, 2020)

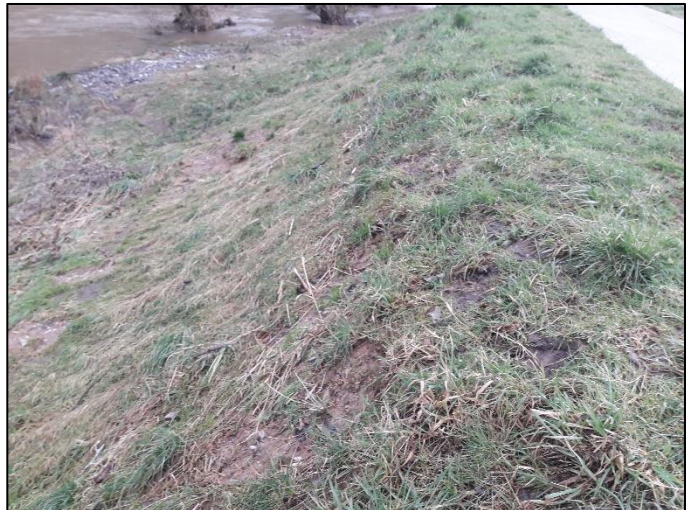
Figure 102: Wrack marks cattle market emb d/s section (NRW, 2020)

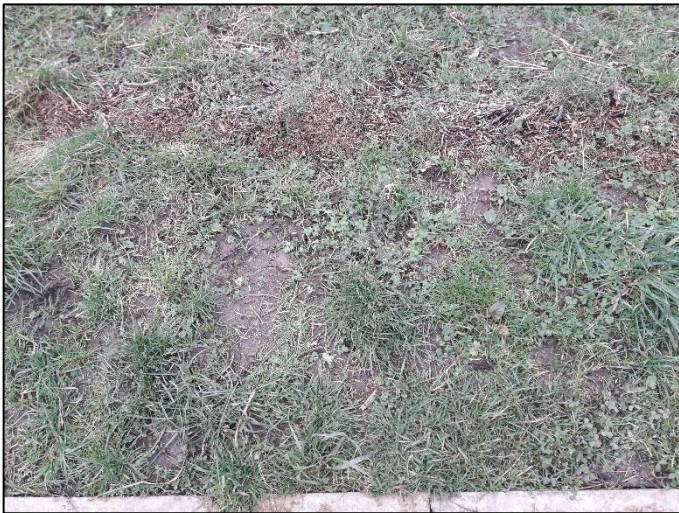
Figure 105: Wrack mark in relation to crest height common emb (NRW, 2020)

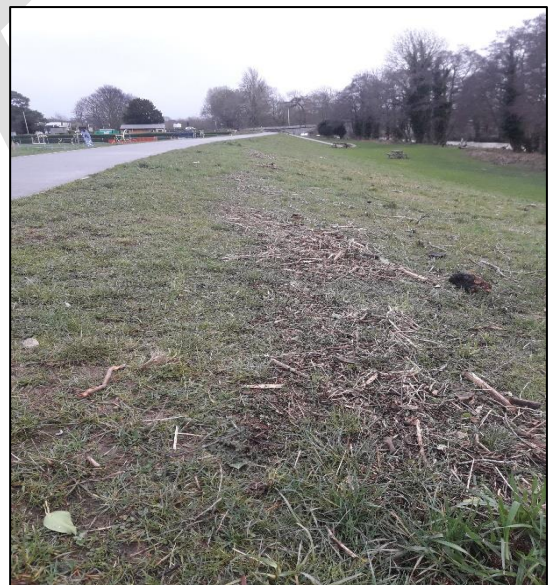
Figure 106: Wrack mark common emb (NRW, 2020)

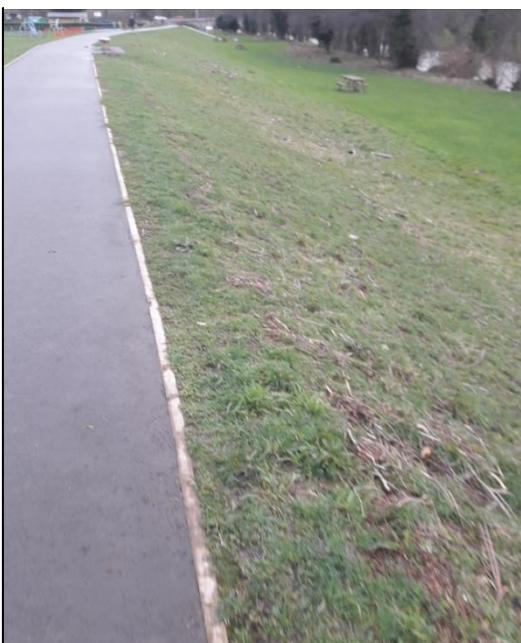
Figure 107: Wrack mark common emb (NRW, 2020)

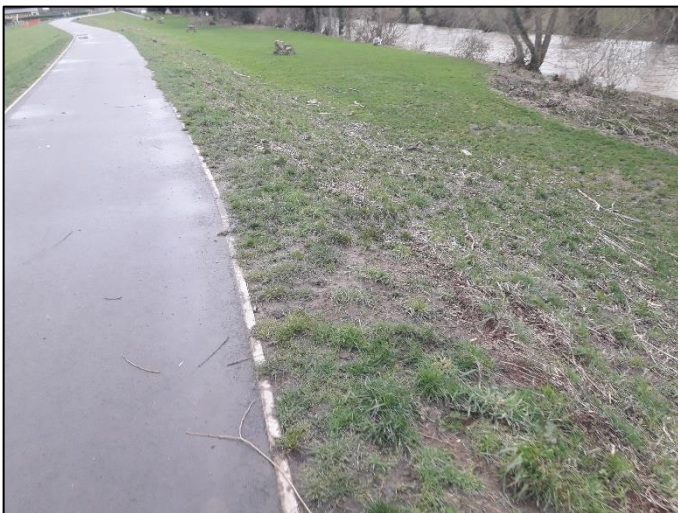
Figure 112: Wrack mark common emb (NRW, 2020)

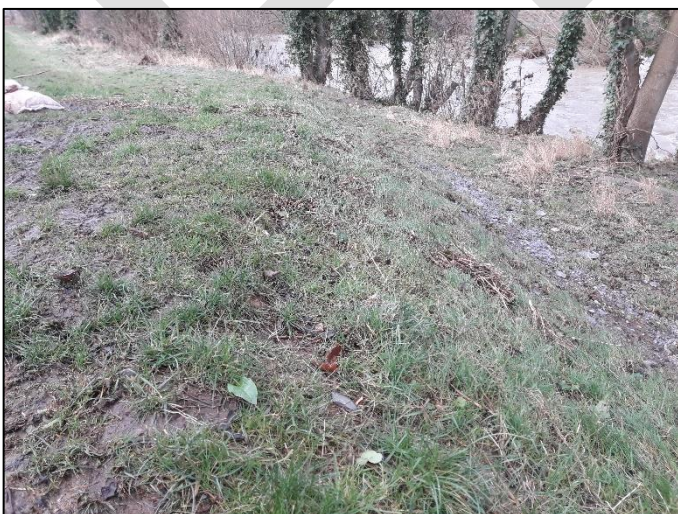
Figure 109: Wrack marks at Roe Parc emb (NRW, 2020)

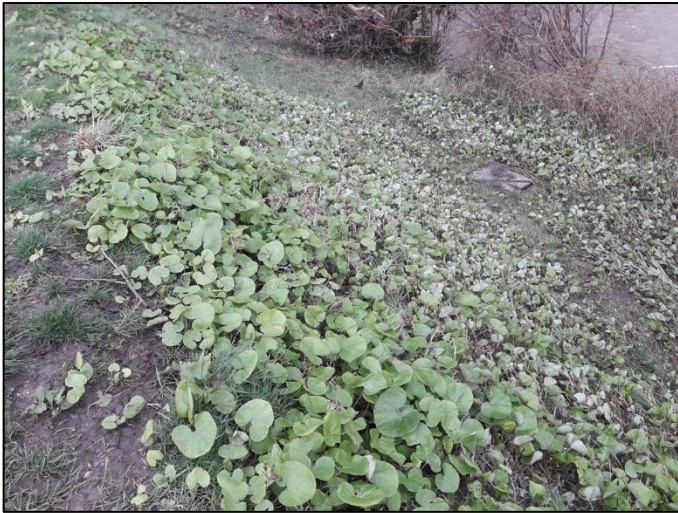
Figure 110: Wrack marks at Roe Parc emb ramp (NRW, 2020)

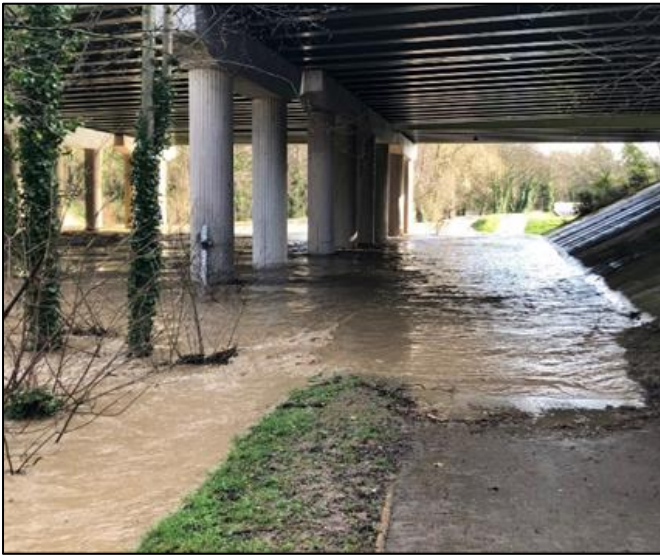
Figure 114: Prior to peak water levels at u/s end of Roe Parc Wall (Resident photo)

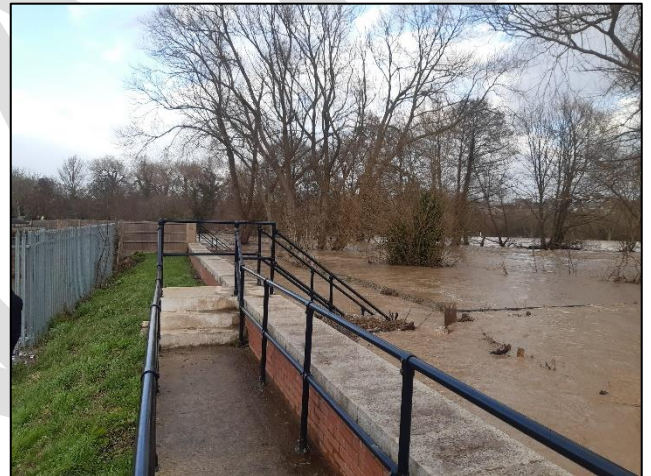
Figure 115: River levels looking d/d from city bridge (NRW, 2020)
